# INNOBIT INDUSTRIES, LLC. FIRE TEST REPORT

ASTM E108 CLASS A BURNING BRAND AND INTERMITTENT FLAME TESTING ON ROOF ASSEMBLY CONTAINING ISTIK SU40 WITH FACER BY GREENPRO UNDERLAYMENT AND GAF® ROYAL SOVEREIGN® 3 TAB SHINGLES.

Q2615.02-121-24 R0

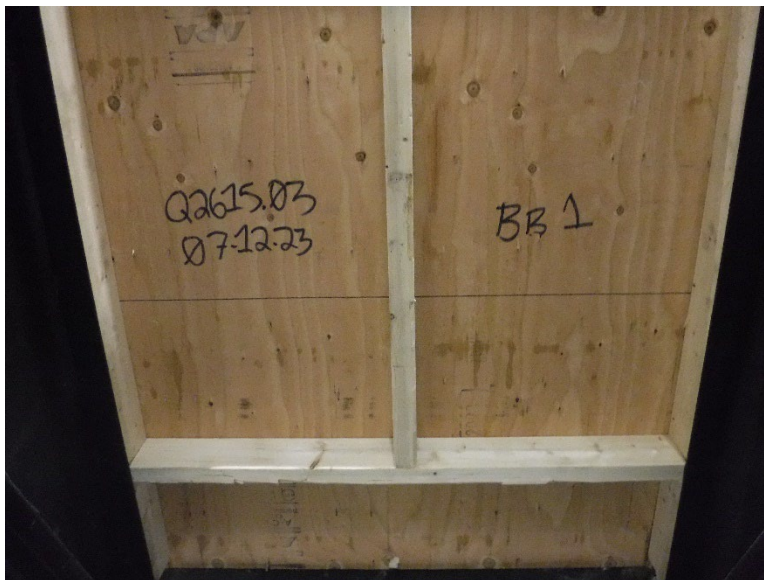
**Photo No. 2**  
**TEST #1 Underdeck Pre-test**

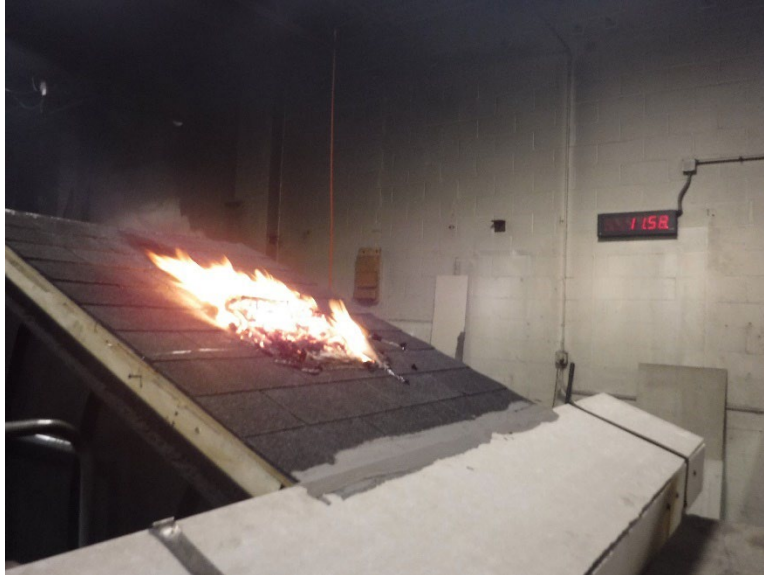
**Photo No. 3**  
**TEST #1 During Test**

<b>TIME (min:sec)</b>	<b>OBSERVATIONS</b>
00:00	Brand placed on deck.
00:51	Sample ignition
03:44	Ignition in front of brand placement
05:41	Smoke at horizontal plywood joint
11:24	Discoloration of plywood at fasteners below horizontal plywood joint
12:16	Dripping at horizontal plywood joint
24:12	Brand consumed
29:08	Smoke at vertical 2X4 below horizontal plywood joint
41:06	Glowing at vertical 2X4 below horizontal plywood joint
90:00	End of Test

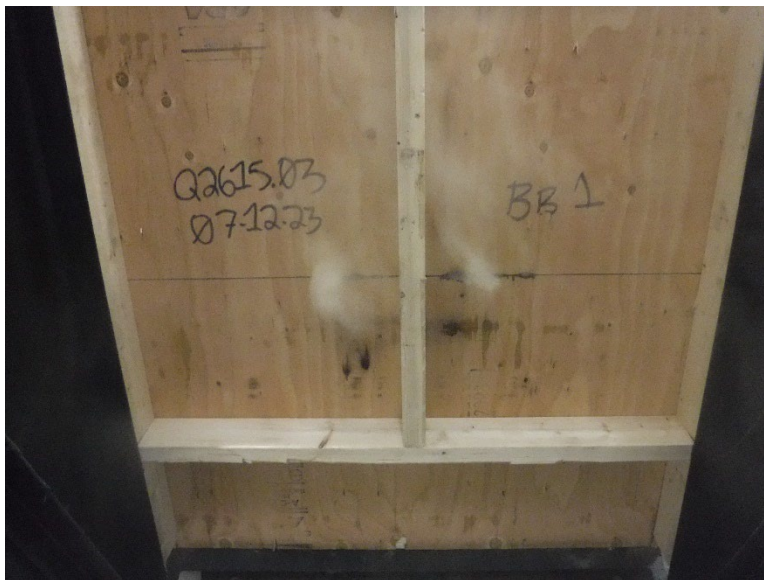
**Photo No. 4**  
**TEST #1 Underdeck During Test**

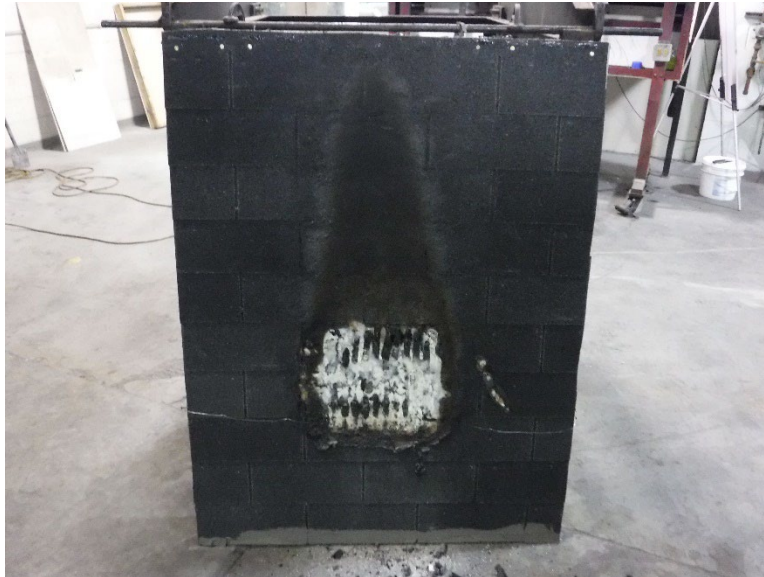
**Photo No. 5**  
**TEST #1 Post Test**

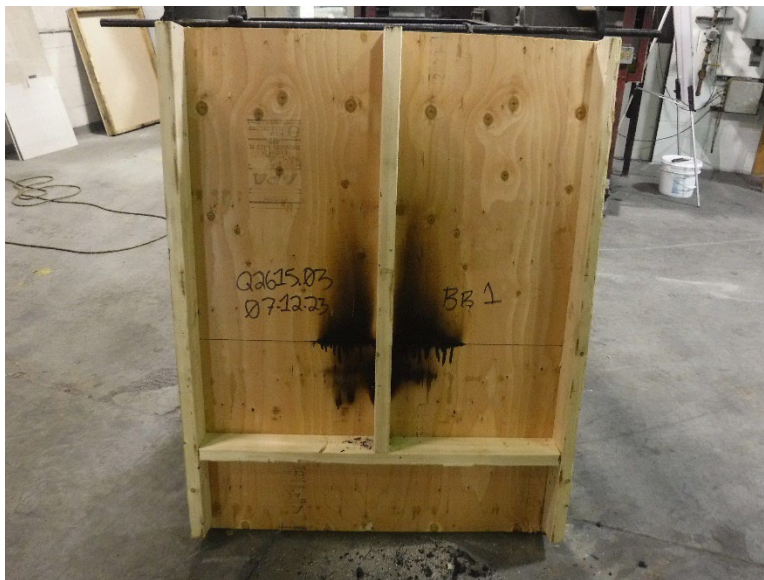
**Photo No. 6**  
**TEST #1 Underdeck Post Test**

Acceptance Level: Class A – No flaming occurred on the underside of the deck.

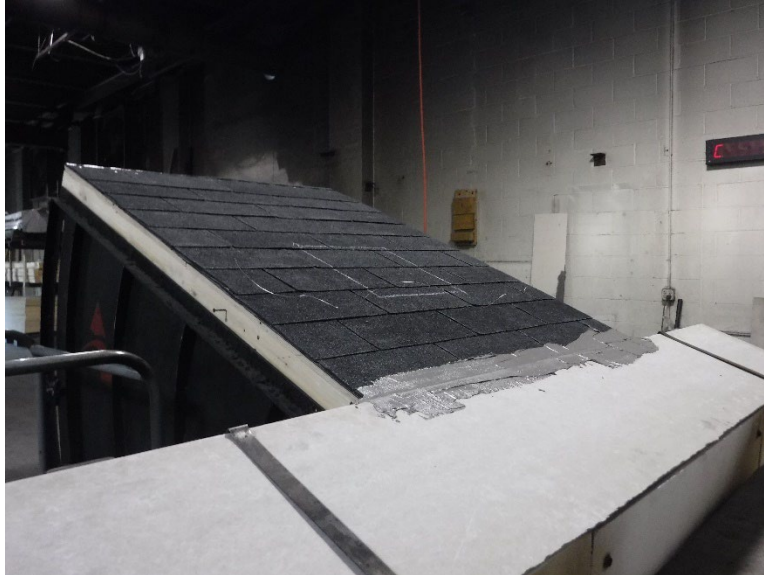
Photo No. 7  
TEST #2 Pre-test

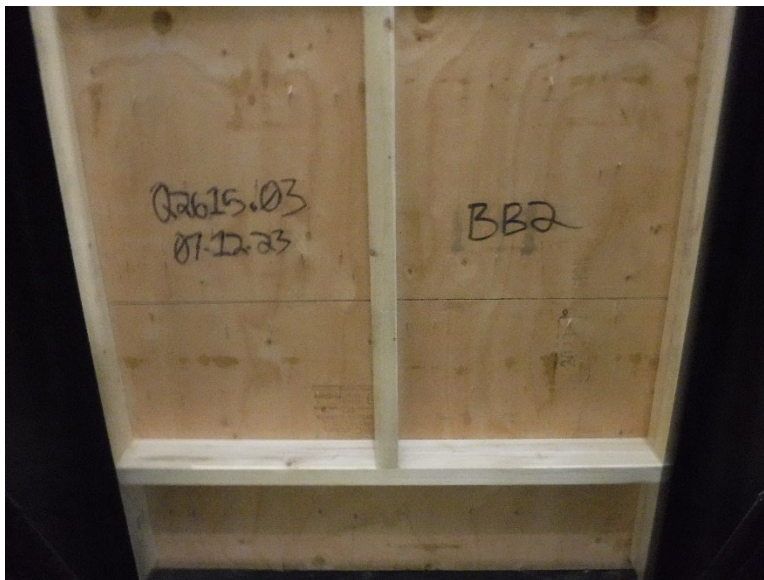
Photo No. 8  
TEST #2 Underdeck Pre-test

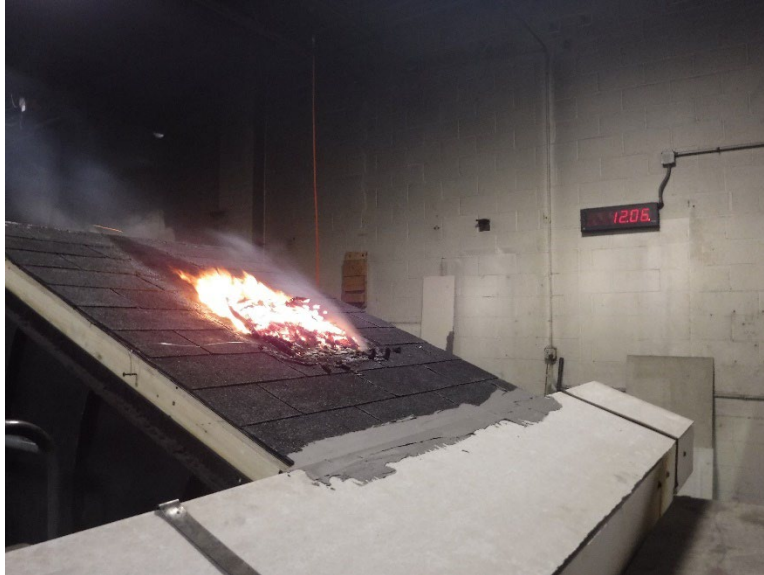
**Photo No. 9**  
**TEST #2 During Test**

TIME (min:sec)	OBSERVATIONS
00:00	Brand placed on deck.
00:59	Sample ignition
03:21	Ignition in front of brand placement
06:07	Smoke at horizontal plywood joint
11:33	Smoke at horizontal plywood joint and vertical 2X4
12:32	Dripping at horizontal plywood joint
14:21	Dripping at horizontal plywood joint and vertical 2X4
15:40	Plywood discoloration at vertical 2X4 below horizontal plywood joint
26:32	Brand consumed
32:37	Smoke at vertical 2X4 below horizontal plywood joint
32:58	Glowing at vertical 2X4 below horizontal plywood joint
90:00	End of Test

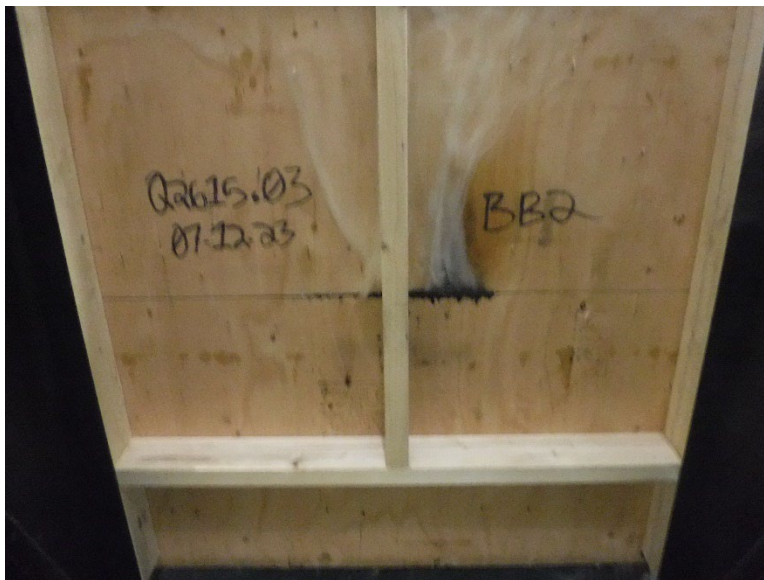
**Photo No. 10**  
**TEST #2 Underdeck During Test**

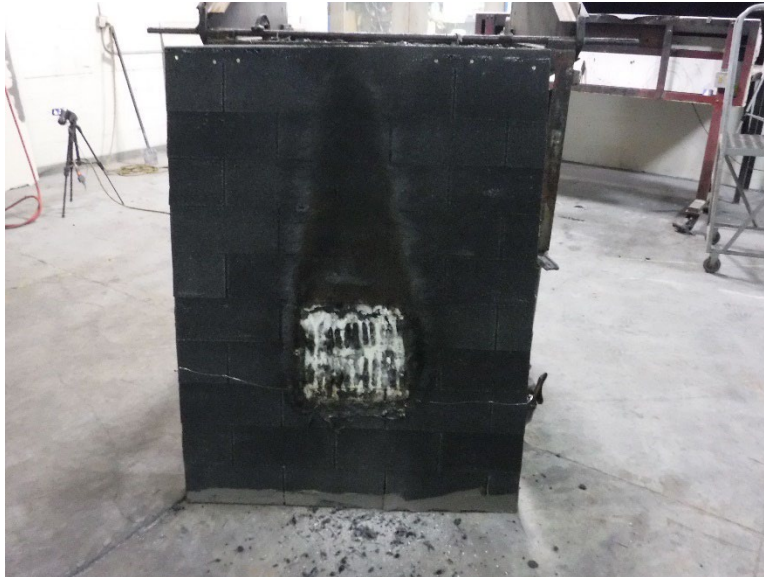
Photo No. 11  
TEST #2 Post Test

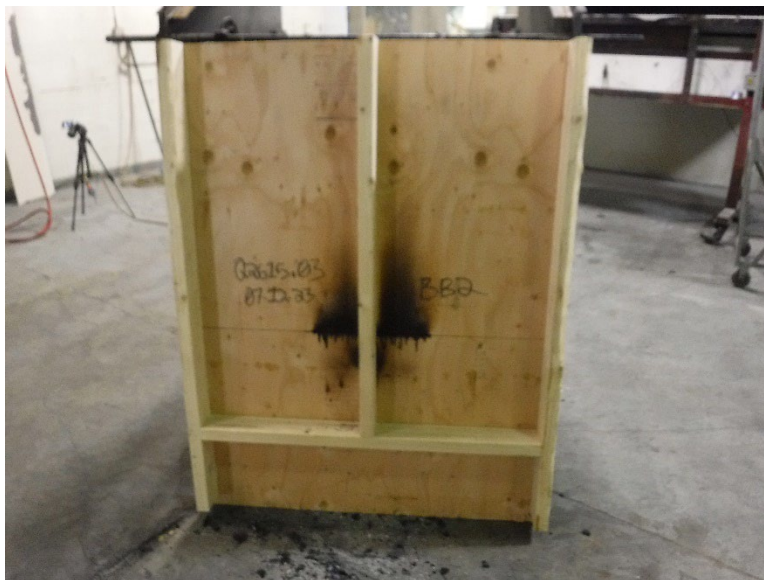
Photo No. 12  
TEST #2 Underdeck Post Test

Acceptance Level: Class A – No flaming occurred on the underside of the deck.

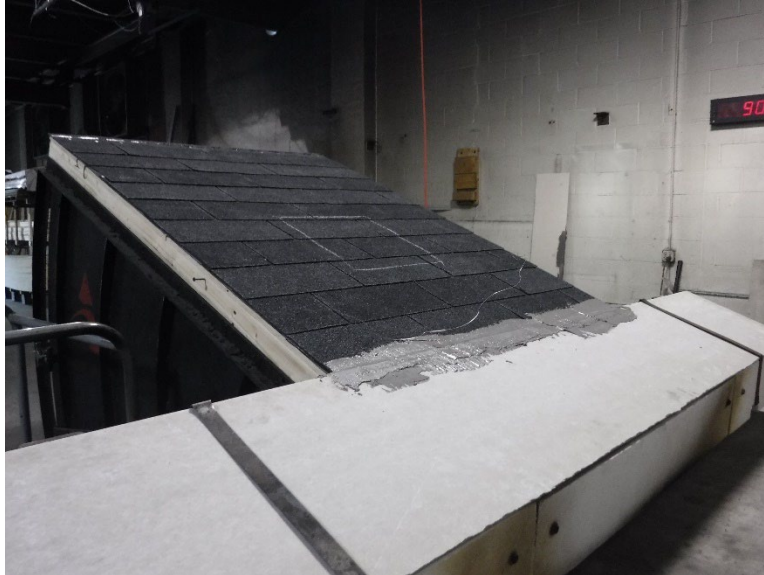
**Photo No. 13**  
**TEST #3 Pre-test**

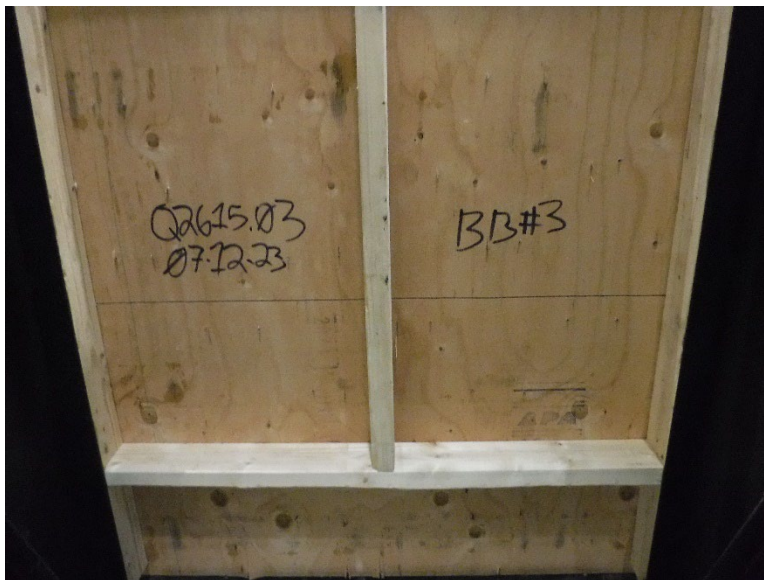
**Photo No. 14**  
**TEST #3 Underdeck Pre-test**

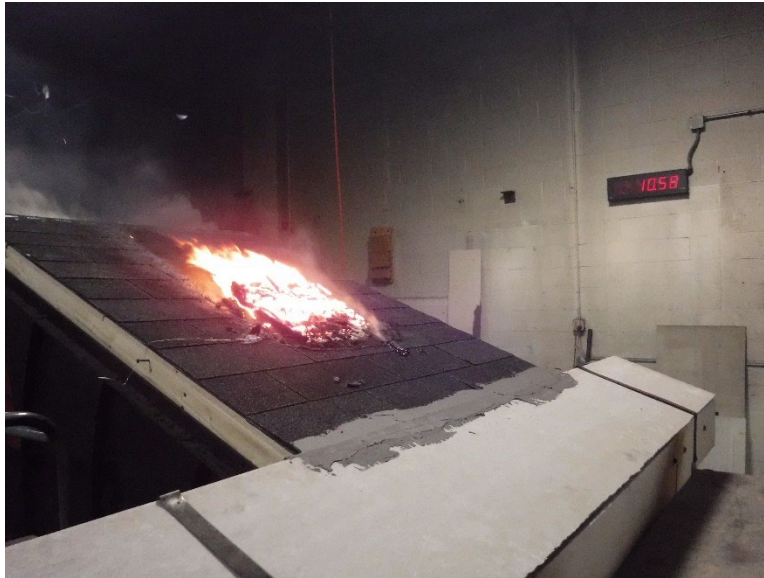
**Photo No. 15**  
**TEST #3 During Test**

TIME (min:sec)	OBSERVATIONS
00:00	Brand placed on deck.
00:58	Sample ignition
02:01	Ignition in front of brand placement
04:41	Smoke at horizontal plywood joint
06:27	Smoke at horizontal plywood joint and vertical 2X4
08:48	Dripping at horizontal plywood joint and vertical 2X4
10:41	Dripping at horizontal plywood joint
13:46	Glowing at horizontal plywood joint and vertical 2X4; plywood discoloration below horizontal plywood joint
23:41	Brand consumed
42:38	No signs of combustion; End of Test

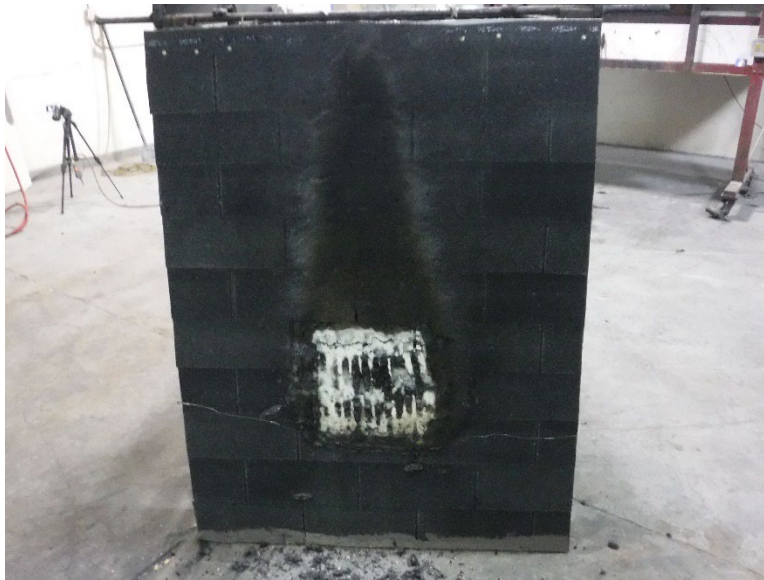
**Photo No. 17**  
**TEST #3 Post Test**

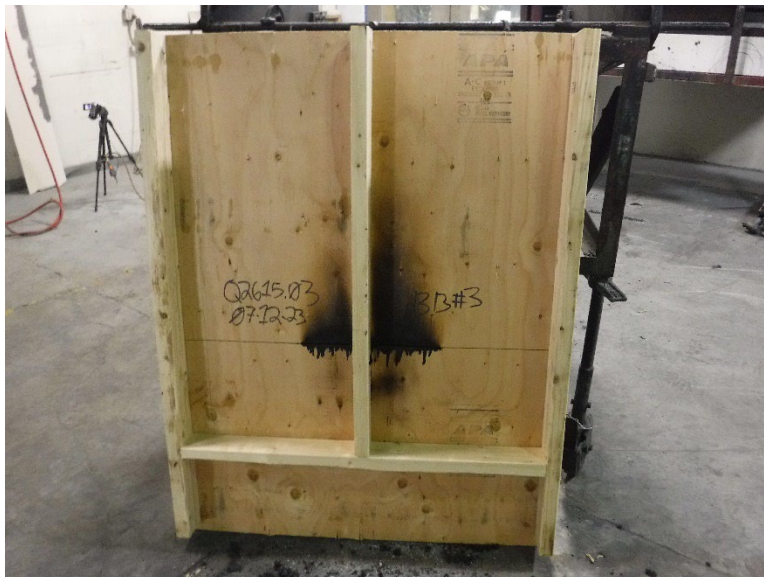
**Photo No. 18**  
**TEST #3 Underdeck Post Test**

Acceptance Level: Class A – No flaming occurred on the underside of the deck.

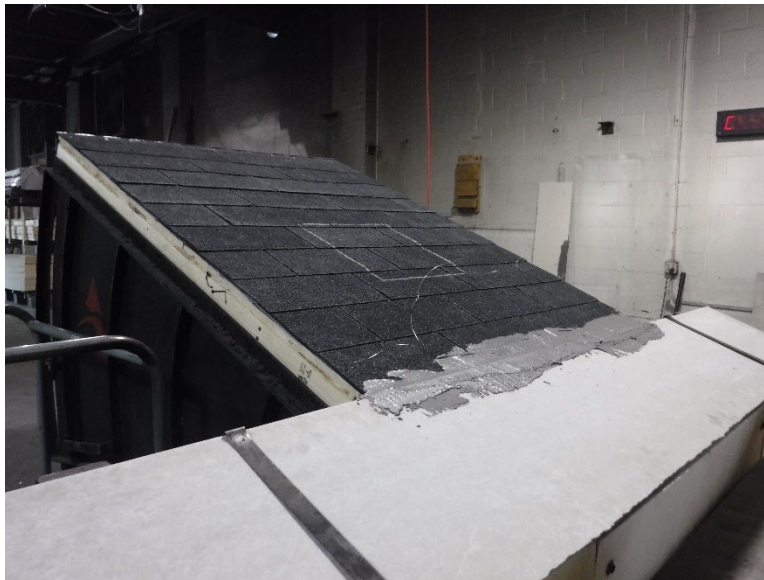
**Photo No. 19**  
**TEST #4 Pre-test**

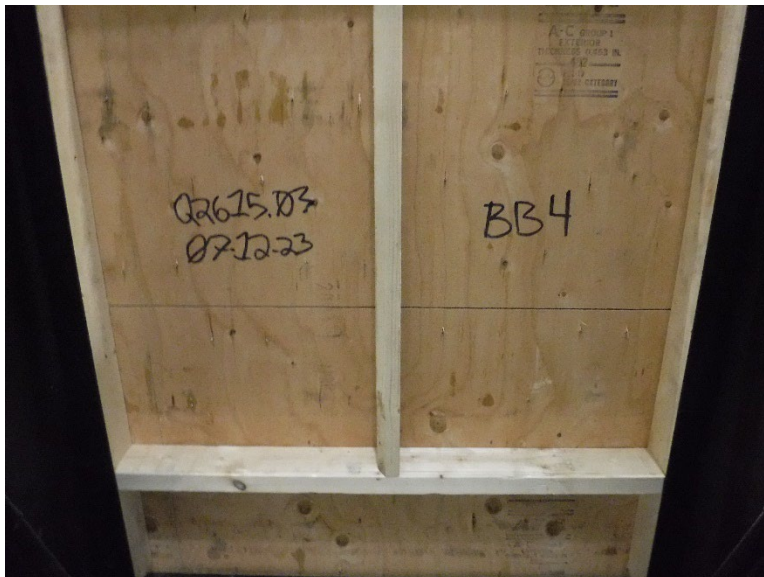
**Photo No. 20**  
**TEST #4 Underdeck Pre-test**

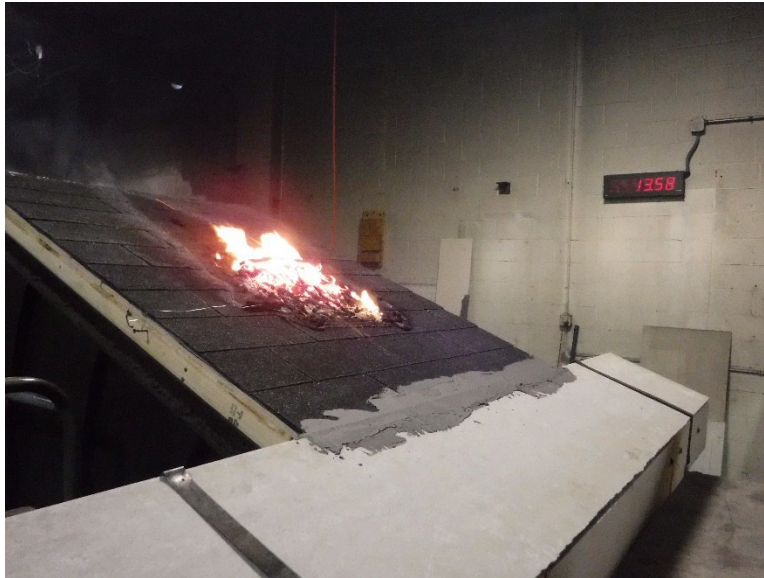
Photo No. 21  
TEST #4 During Test

<b>TIME (min:sec)</b>	<b>OBSERVATIONS</b>
00:00	Brand placed on deck.
01:01	Sample ignition
03:23	Ignition in front of brand placement
05:58	Smoke at horizontal plywood joint
11:46	Dripping at horizontal plywood joint
13:25	Plywood discoloration at vertical 2X4 below horizontal plywood joint
15:29	Smoke from plywood below horizontal plywood joint
20:47	Brand consumed
24:36	Smoke at vertical 2X4 below horizontal plywood joint
43:20	Glowing at vertical 2X4 below horizontal plywood joint
80:25	No signs of combustion; End of Test

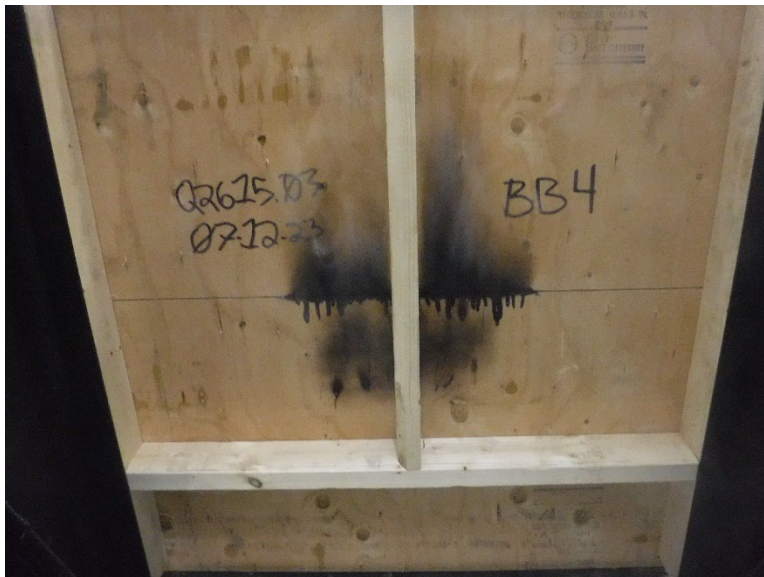
Photo No. 22  
TEST #4 Underdeck During Test

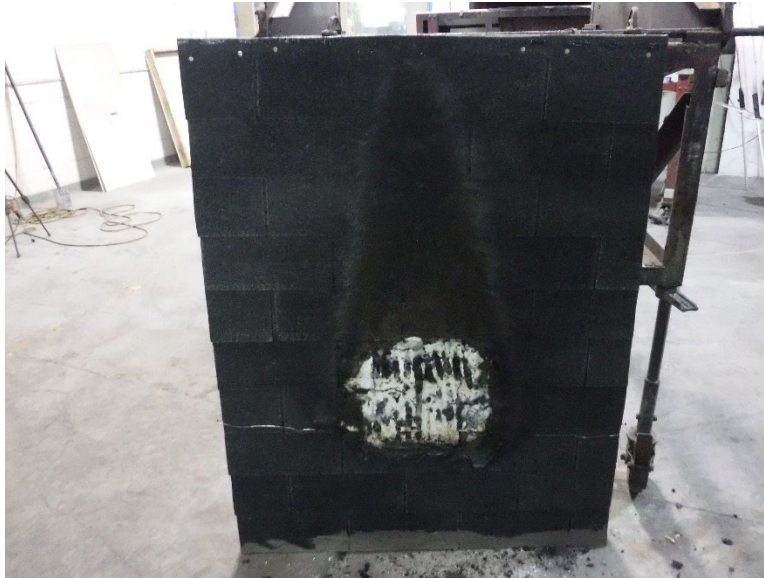
**Photo No. 23**  
**TEST #4 Post Test**

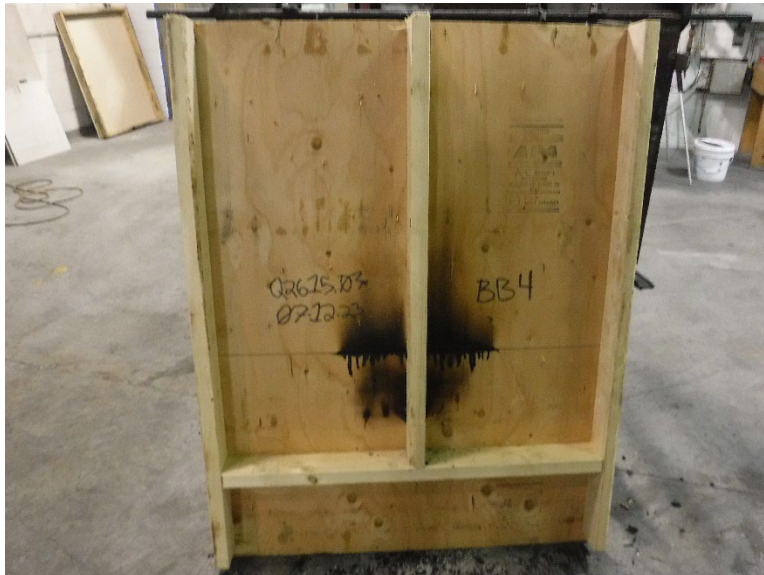
**Photo No. 24**  
**TEST #4 Underdeck Post Test**

Acceptance Level: Class A – No flaming occurred on the underside of the deck.

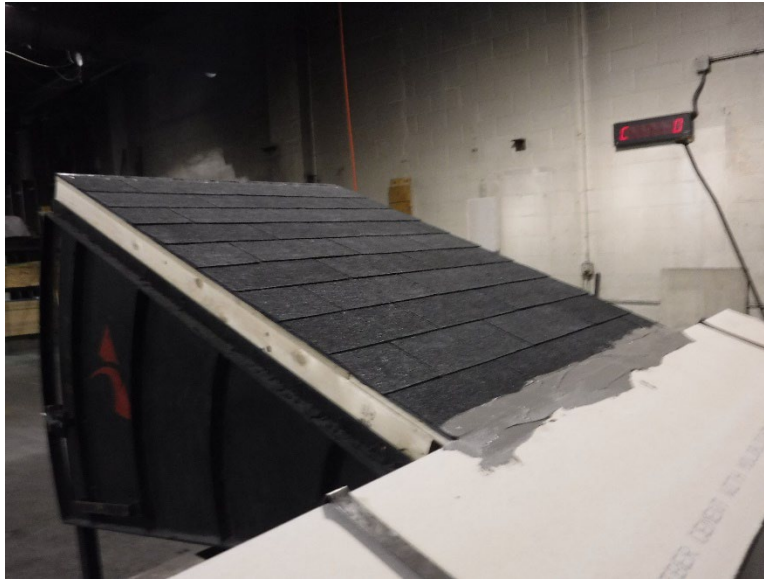
Photo No. 25  
TEST #5 Pre-test

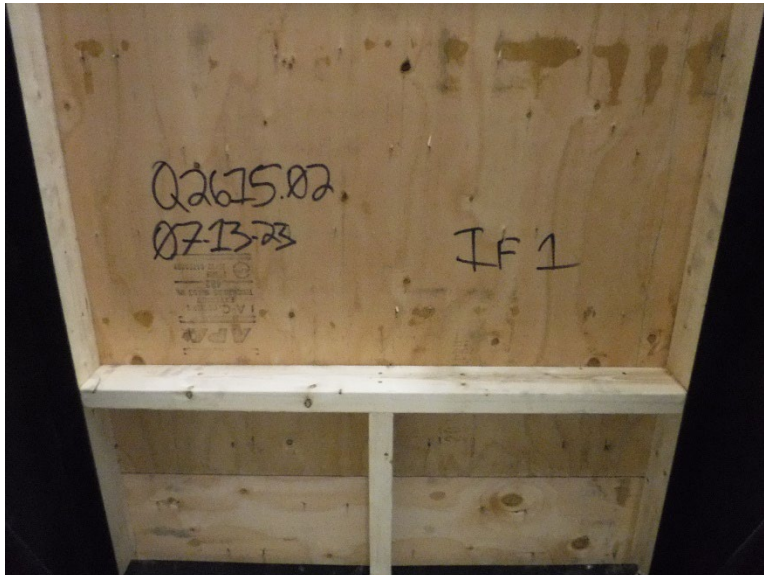
Photo No. 26  
TEST #5 Underdeck Pre-test

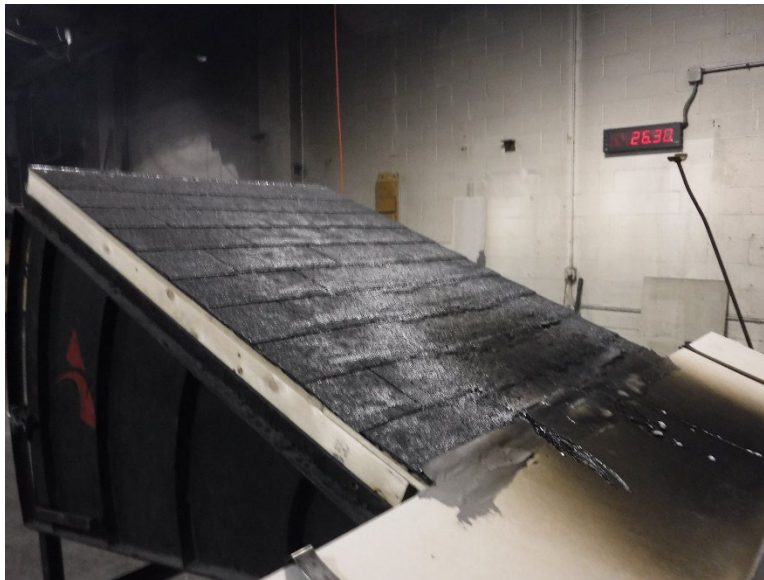
Photo No. 27  
TEST #5 During Test

CYCLE		Flame	
NO.	TIME.	ON/OFF	OBSERVATIONS/COMMENTS
4	13:37	ON	Sample ignition
4	14:14	OFF	Smoke at leading edge of underdeck
4	14:31	OFF	Sample Extinguished
5	16:03	ON	Dripping at horizontal plywood joint
5	17:41	ON	Reignited
5	18:24	OFF	Extinguished
6	21:51	ON	Reignited
6	22:17	OFF	Extinguished
XXX	60:00	XXXXX	All flame cycles complete; start observation period
XXX	74:24	XXXXX	No signs of combustion of the underdeck; End of Test

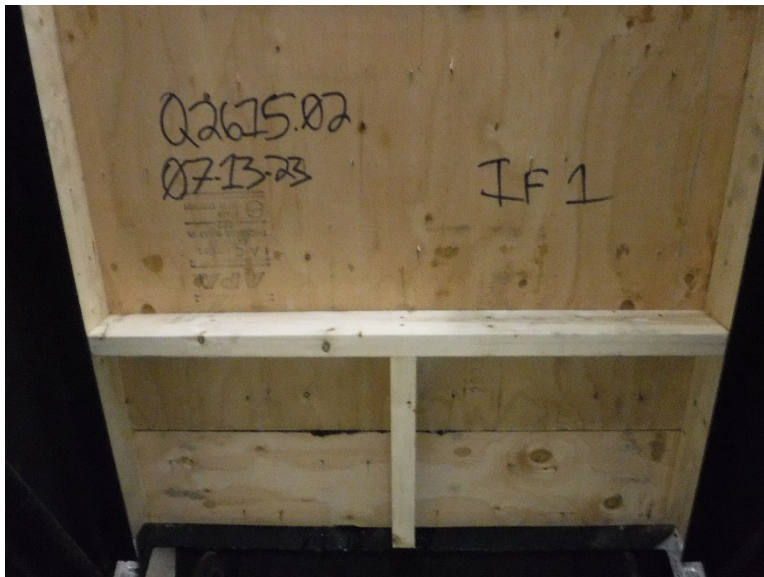
Photo No. 28  
TEST #5 Underdeck During Test

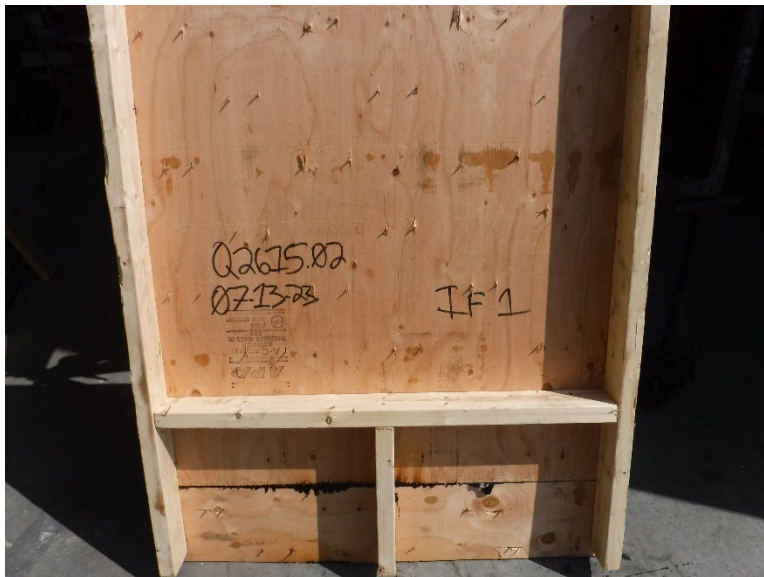
**Photo No. 30**  
**TEST #5 Underdeck Post Test**

Acceptance Level: Class A – No flaming occurred on the underside of the deck.

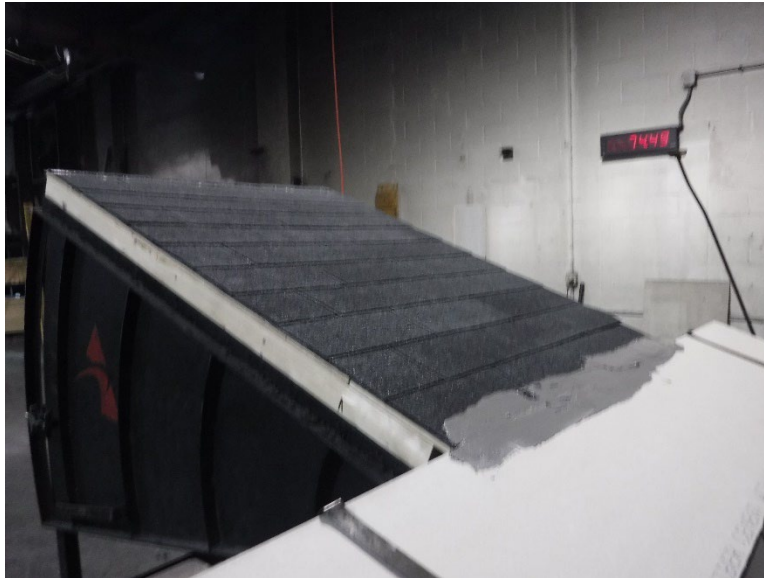
Photo No. 31  
TEST #6 Pre-test

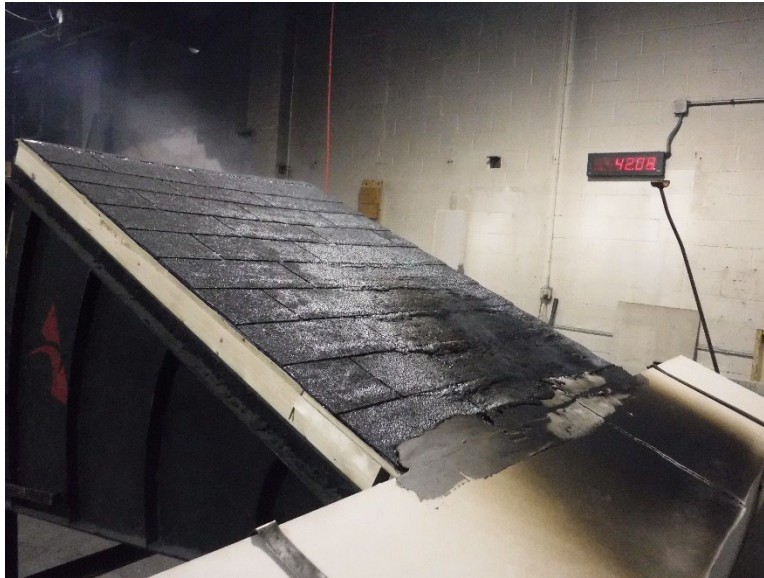
Photo No. 33  
TEST #6 During Test

CYCLE		Flame	
NO.	TIME.	ON/OFF	OBSERVATIONS/COMMENTS
3	14:06	OFF	Smoke at leading edge of underdeck
5	17:55	ON	Sample ignition
5	18:03	OFF	Extinguished
6	21:57	ON	Reignited
7	24:44	ON	Dripping at horizontal plywood joint
10	39:37	OFF	Extinguished
XXX	60:00	XXXXX	All flame cycles complete; start observation period
XXX	71:02	XXXXX	No signs of combustion of the underdeck; End of Test

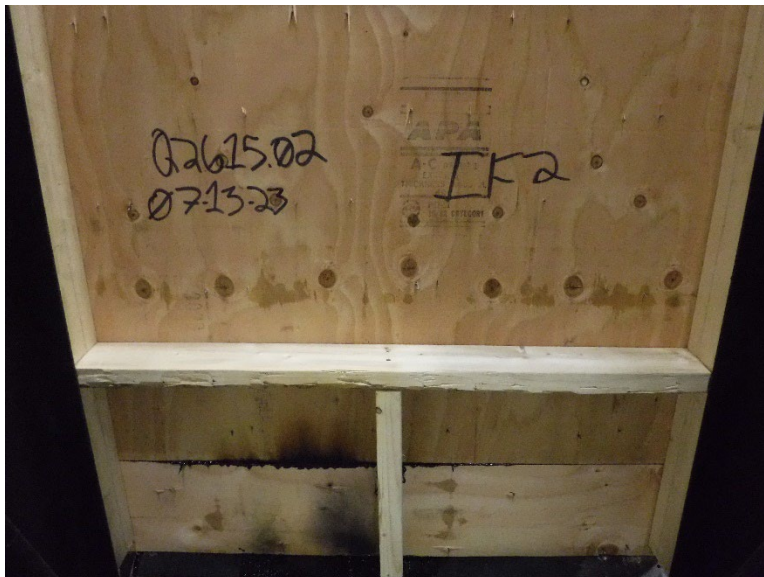
Photo No. 34  
TEST #6 Underdeck During Test

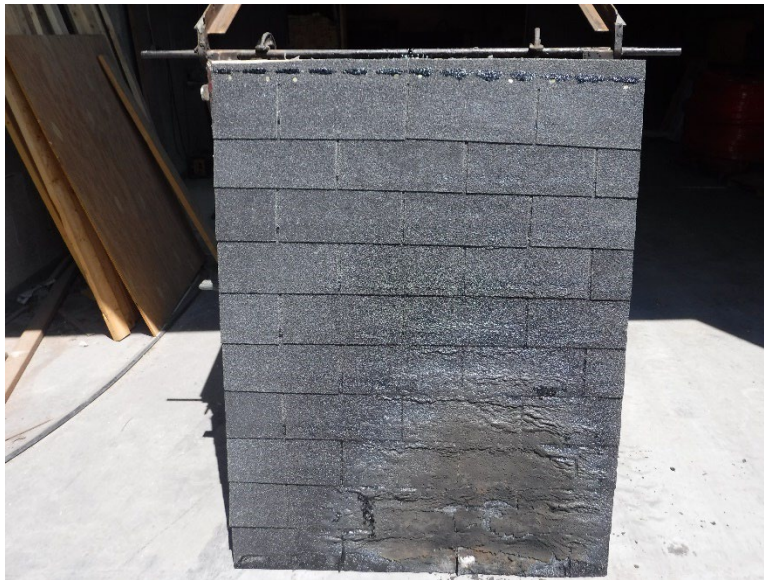
**Photo No. 35**  
**TEST #6 Post Test**

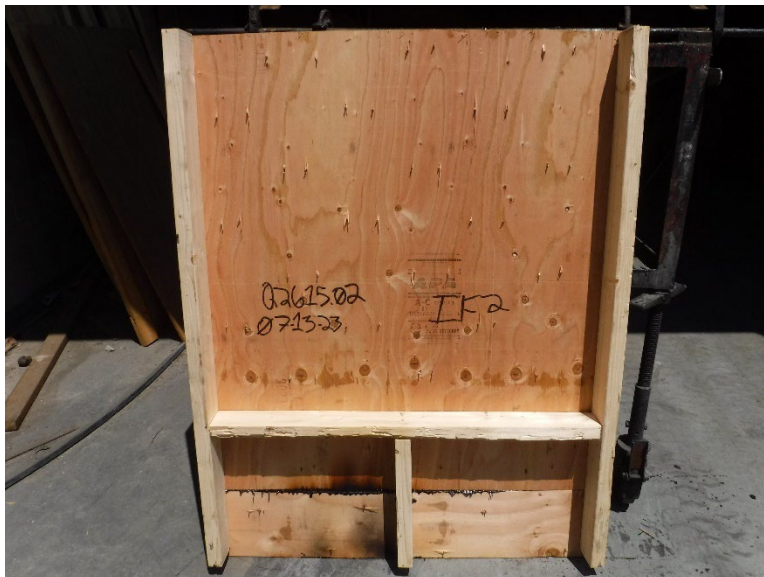
**Photo No. 36**  
**TEST #6 Underdeck Post Test**

Acceptance Level: Class A – No flaming occurred on the underside of the deck.
