St. Jude Medical Center New roof meets new FM Global requirements

Caguas, Puerto Rico

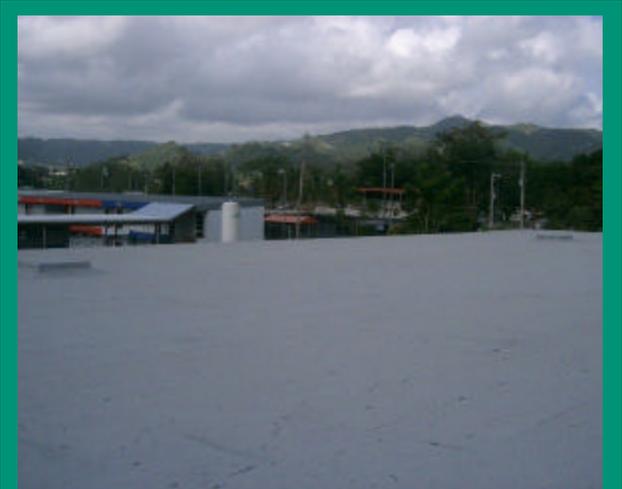
High winds are a part of Puerto Rico's environment; so is the damage they cause. For medical device manufacturer St. Jude Medical Center, a blown off roof could be a disaster.

Tremco roofing consultant Francisco Mirandes and Atlas Roofing Contractors stepped in to handle the complex project. Conditions included no interruptions to ongoing operations and no leaks during the job; competitive pricing; local manufacturer representation; and support after project completion. Plus the project had to meet new FM Global requirements in Puerto Rico (specifically, class 1A 1-180 over metal deck with a deck joist spacing of 7'6").
