## RESTORATION PROJECT PROFILE

# AHU RESTORATION SAVES BEACON HEALTH MORE THAN \$2 MILLION

South Bend, Indiana

**Project Type:** Air Handler Restoration

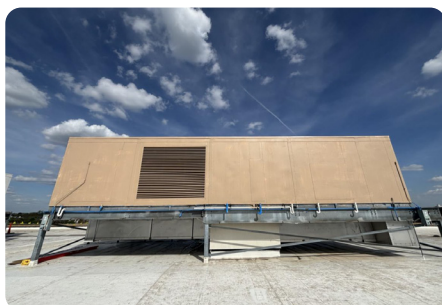
AHU Exterior Before

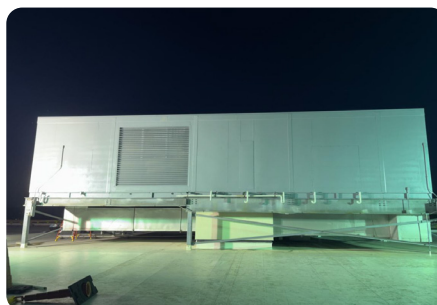
AHU Exterior After

Rather than default to replacement, the Beacon Health facilities team partnered with WTI PureAir to take a smarter path. Working overnight to keep the hospital fully operational, the team restored each unit from the inside out: deep-cleaning coils to recover proper airflow, applying a corrosion and microbial-resistant coating to cabinet surfaces, and upgrading drain pans to anti-viral and anti-microbial standards.

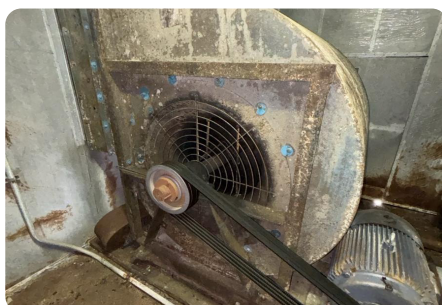
Before Fan Array Retrofit

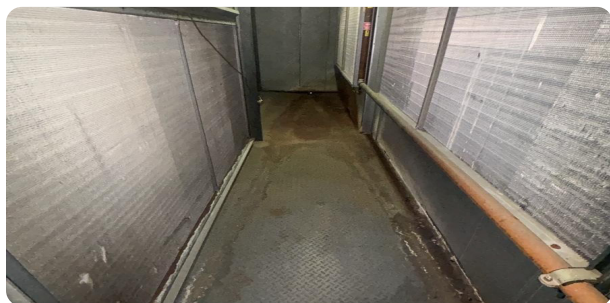
Before High-Performance Coating

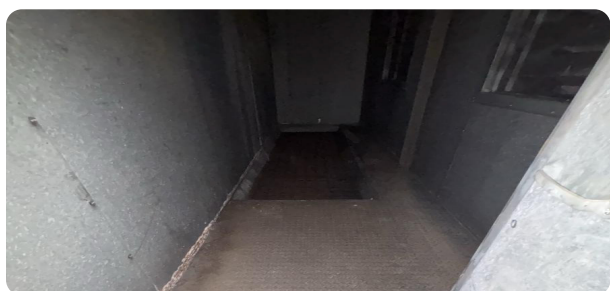
Fan Array Before

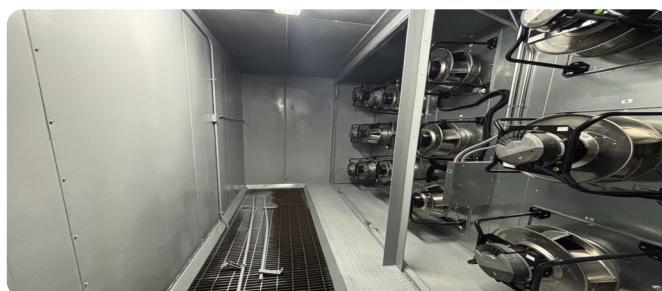
Fan Array After

The ECM fan array retrofit eliminated belts and grease fittings for good, replacing them with a redundant system where a failed fan is resolved by a simple swap, not a service call. After five nights on AHU-1 and nine on AHU-3, both units performed like new, backed by a five-year parts and labor warranty and Beacon Health saved more than \$2 million with zero downtime.

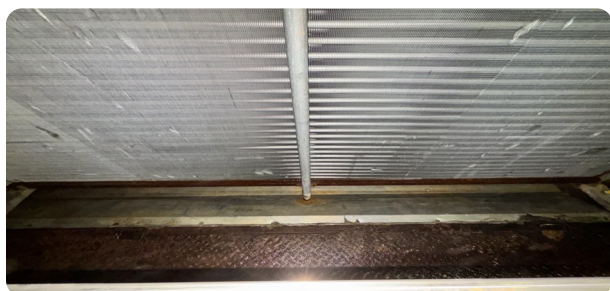
Before Drain Pan Protection

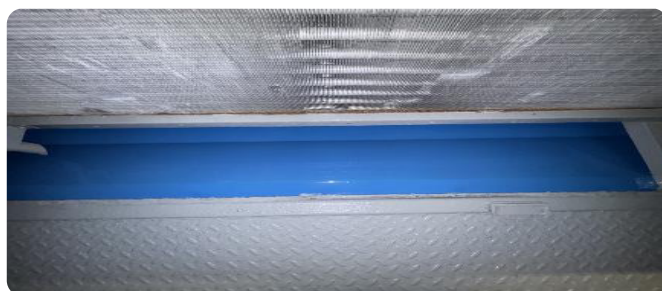
After Drain Pan Protection
