Maximillian Kolbe Church Metal roof polishes off years of problems

Toms River, New Jersey

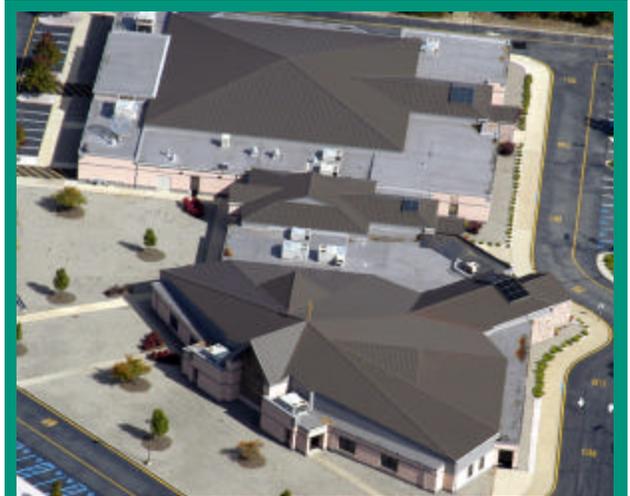
Gleaming metal replaces leaky shingle roof

They found a roof in extremely bad shape. The shingles had failed and roof venting was poor. Fortunately the underlying deck was in good shape.

The team tore off the old shingle roof and base felt down to the iso/wood composite deck, ensured that the venting would be good, and adhered a new base felt layer to the deck. They then installed approximately 38,000 square feet of the new TremLock VP metal roof system.
